July 24, 2018

Subject: Steel Inventory and Sample Plan for Structural Steel  
New Milford CEC Project

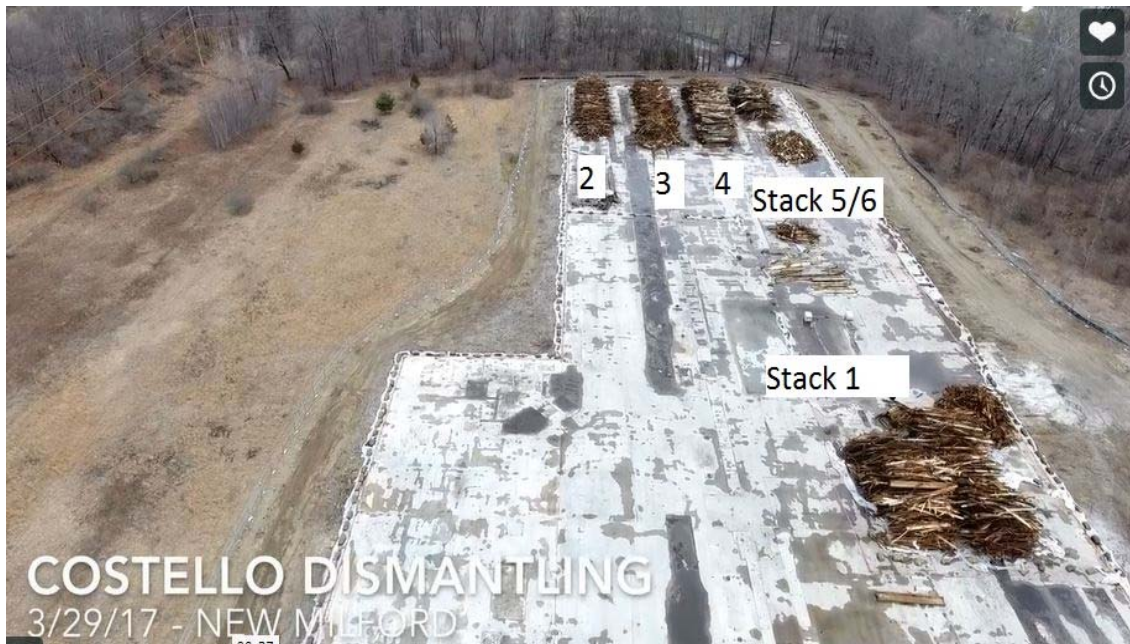
**Figure 1**

The resulting structural steel members were staged in piles as the building was being demolished. These structural steel members were then staged in stacks on the northern portion of the building slab. There are currently 6 stacks (Stacks 1 through 6) of steel present on the northern end of the building slab. These stacks were made up of a variety of structural steel building components (i.e. beams, columns and roof truss systems). Figure 1 provides the location of each stack on the former building slab and Table 1 provides its approximate volume as a total of the steel remaining on site.

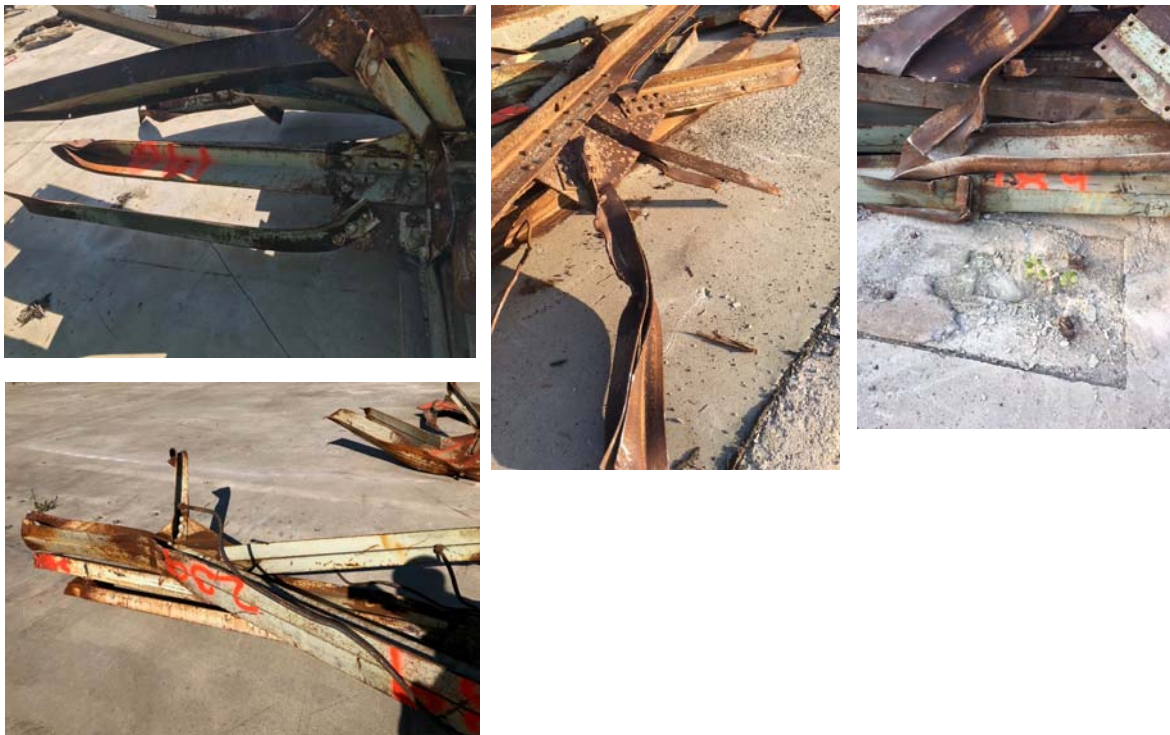
The roof truss bracing system incorporates multiple components of various sizes. They were removed as a group, as evidenced in the photos below. Numerous small sections of these assemblies were identified in each of the stacks and, as proposed previously, they will be handled and sampled as a group.

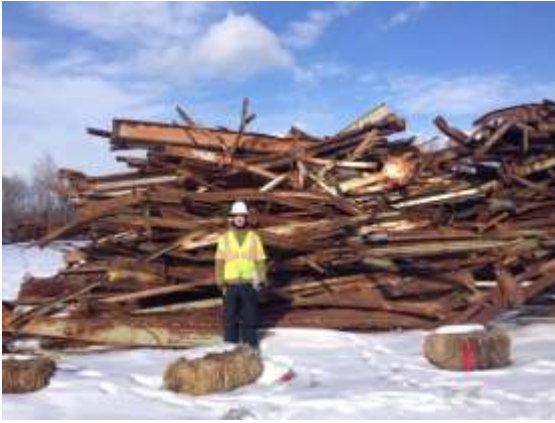
**Stack 1 (Looking North)**

To date approximately 17.5% of the steel on site has been decontaminated using the low pressure water jet method. This steel has been separated from the other steel in a single stack, herein identified as Stack 1 to aid discussion. Stack 1 was further divided based on the size of various portions of the stack, as follows:

- Section 1: ~24' by 48' by 12' high
- Section 2: ~20' by 24' by 12' high
- Section 3: ~25' by 24' by 4' high
- Section 4: ~15' by 24' by 12' high

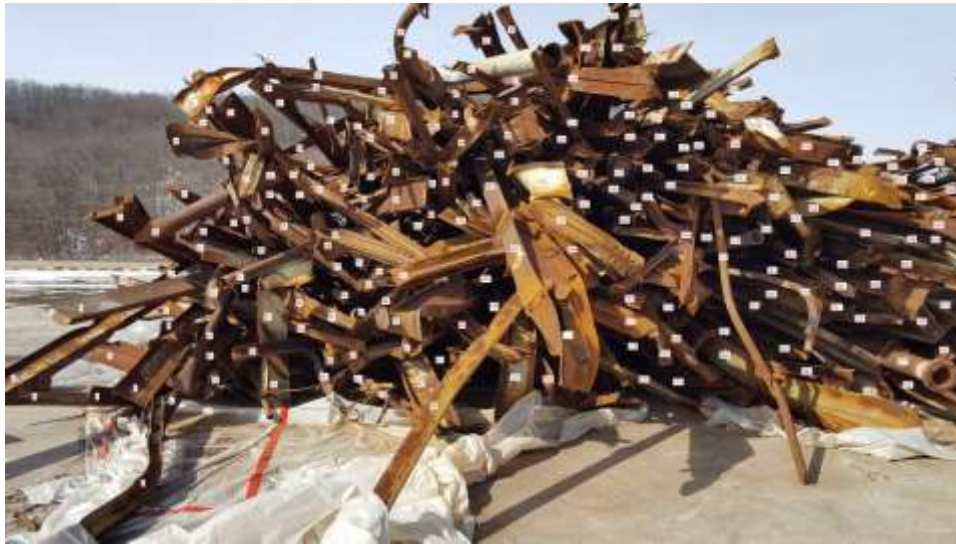
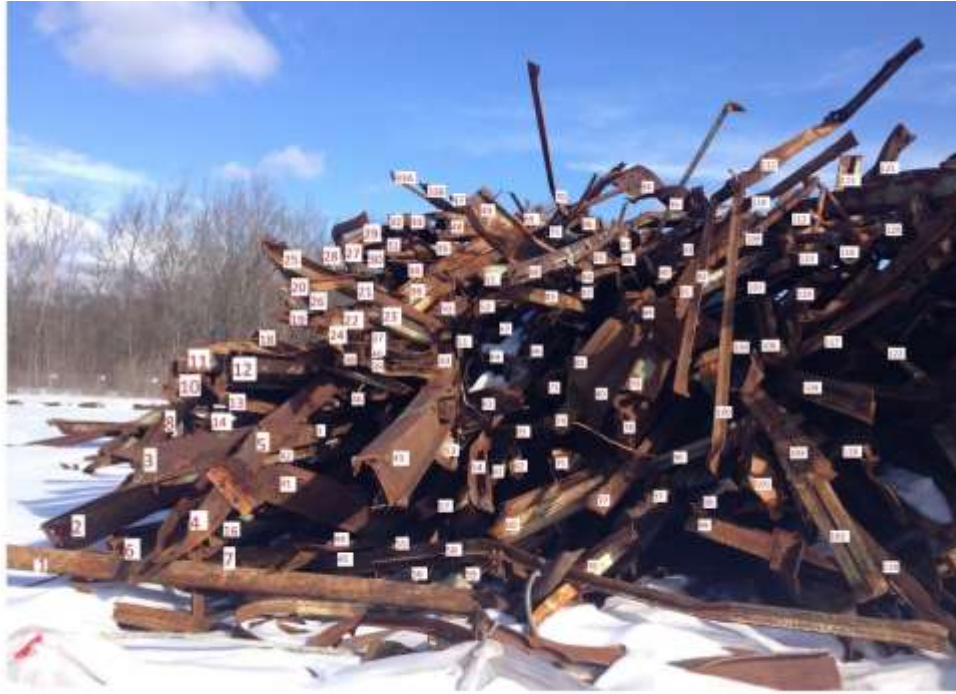
### **Sections Inventoried**

An inventory of the steel beams was conducted for 2 different sections ( $\frac{1}{3}^{\text{rd}}$  of section 1 and all of Section 2) which represents~ 33% of the total Stack 1 size. The quantities of each type of structural member were counted and the quantities were then extrapolated to provide an approximation of the total quantity of each type of structural member in the entirety of Stack 1.

The purpose of this inventory was to determine the approximate number and size of components (columns, beams, channels, angle irons and trusses) in each stack and confirm that these stacks are representative of the steel inventory on site. This data was then used to develop the sample plan for the stack presented below.

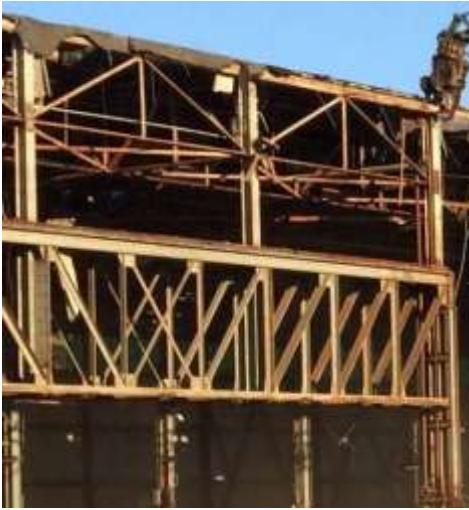
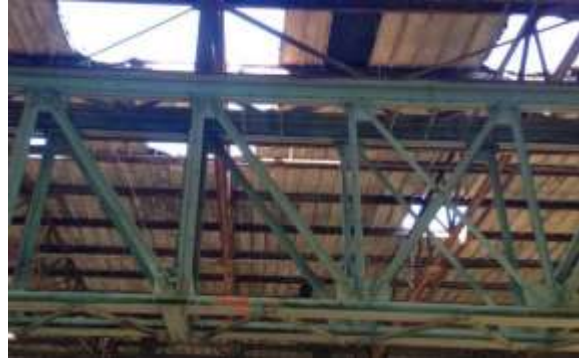
The individual beam sizes are grouped by function. For example, the roof truss bracing system incorporates multiple components of various sizes and will be sampled as a group.

Pictures of the beams, columns and roof truss system have been provided in Attachment 2, the SES report on column and truss sampling.

In order to confirm that the roof truss system can be classified as an Excluded PCB Product (<50 ppm), a total of 10 components, representing the various types of components in the truss system, will be selected and sampled.

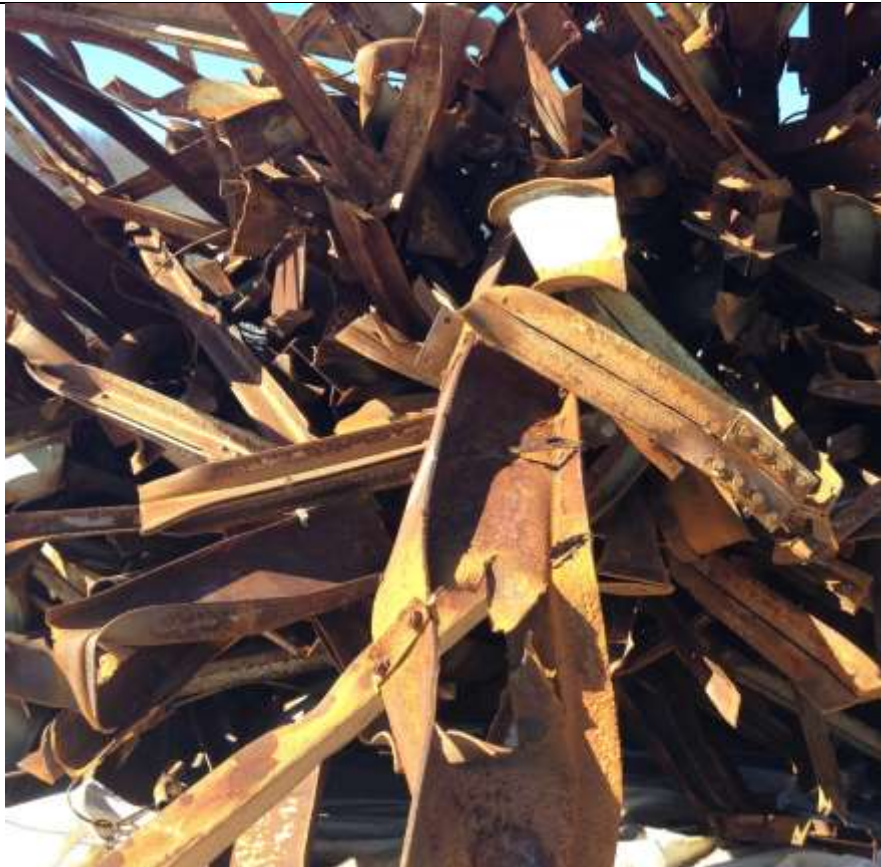
It should be noted that, as indicated in the picture below, many sections of the roofing support structure consists of multiple size components which remained connected. These sections were generally much shorter than the other beams. These were 'counted' as the size beam most predominant in the section.
